Knee Surg Sports Traumatol Arthrosc (2008) 16:56–63  
DOI 10.1007/s00167-007-0416-7

# Effects of a contoured articular prosthetic device on tibiofemoral peak contact pressure: a biomechanical study

Christoph Becher · Roland Huber ·  
Hajo Thermann · Hans H. Paessler ·  
Gobert Skrbensky

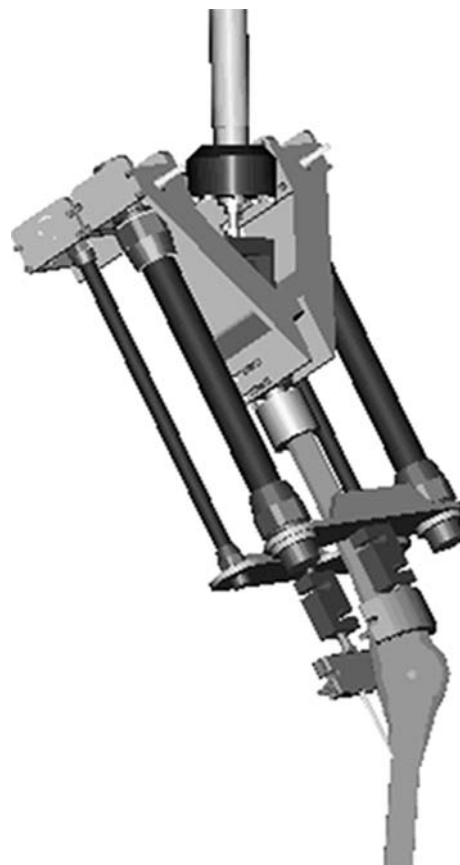
A specially designed knee simulator was used for this study (Fig. 1). Similar to in vivo conditions, the main system composed of artificial muscle, force transducer sensor, the joint angle detection and the ground reacting force form a closed loop. The ground reaction force is adjustable according to the donor's weight. The knee simulator consists of a loading frame (MTS 858 Bionix, MTS Systems,

**Fig. 1** Schematic drawing of the knee simulator that was used for this study

Eden Prairie, MN, USA) with a long stroke main actuator driven by a hydraulic pump unit (MTS 505.11 silent flow) to simulate body weight and the vertical hip displacement in the mechanical axis of the lower limb. Ankle joint simulation is performed with a hinge joint with one free motion axis. The possible rotation during the movement occurs in the artificial hip joint as if standing with fixed shoe contact. A load transducer is fixed between the mounting plate and ankle joint to detect the vertical ground reacting force (U3 load cell, Hottinger-Baldwin, Darmstadt, Germany). Two smaller actuators apply loads, which simulate the quadriceps force. The tendons of the quadriceps muscle are attached to customized curved cryo-clamps, which avoid patella tilting. These cryo-clamps are connected to a waterproof force transducer (SSM-AJ 500, Interface, Scottsdale, AZ, USA) and connected to an artificial muscle (Fluidic muscle MAS, Festo, Esslingen, Germany). The mathematical model shows that the properties of this fluidic muscle is comparable with a skeletal muscle [28].
